Human Nutrition

Poultry and processed meats business

INSTALLATION DETAILS

3 Months Test Report

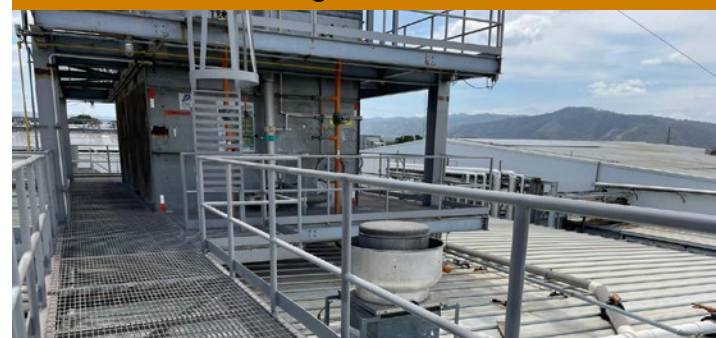
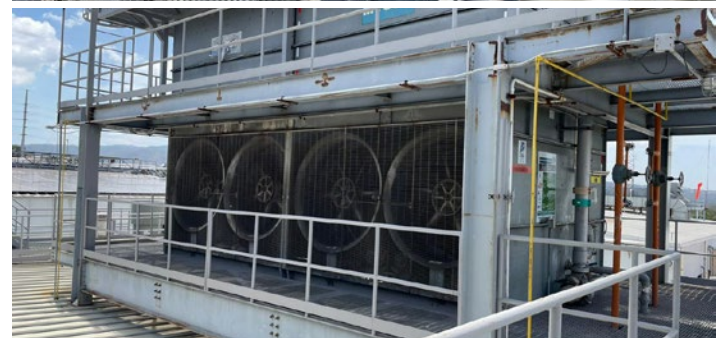
Refrigeration area

Installation of Vulcan S25 on a 2" (DN50) steel pipe

Models:   **Vulcan S25** is installed on: 2" steel pipe at the refilling line of the refrigeration area.
Water capacity: 20 m³/h

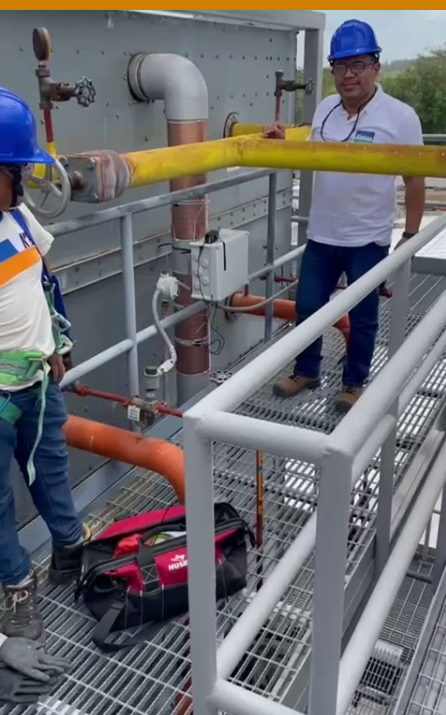
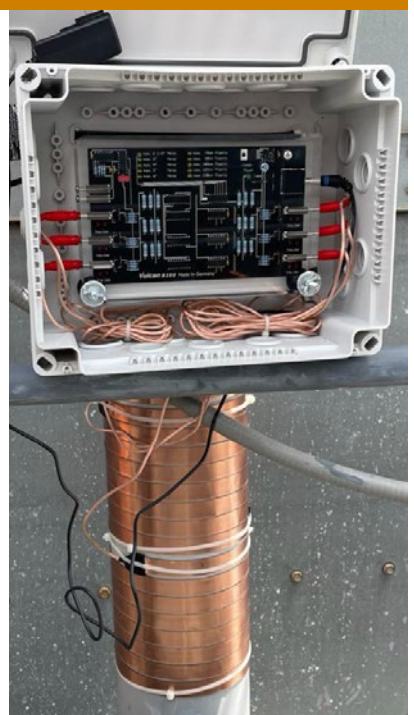
Installation of Vulcan S100 on a 6" (DN150) PVC pipe

**Vulcan S100** is installed on: 6" PVC pipe at the close circuit of the condenser of the refrigeration area.
Water capacity: 40 m³/h

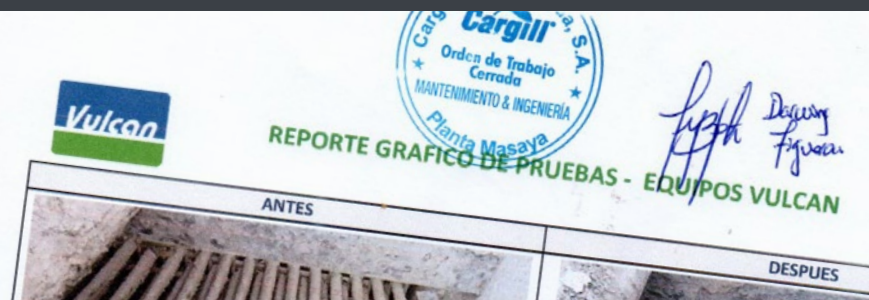
Four witness points were selected (portions of about 15 cm of pipe) and the limescale was removed mechanically, this to verify if there is re-incrustation with Vulcan during the test period. After 3 months, the results are as follows:

1. The witness pipes remain free of new limescale.

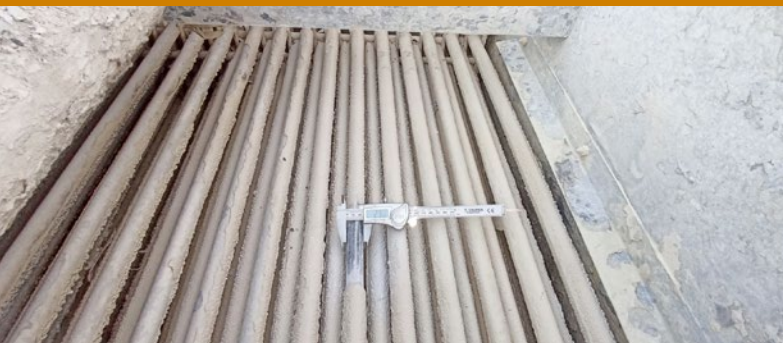
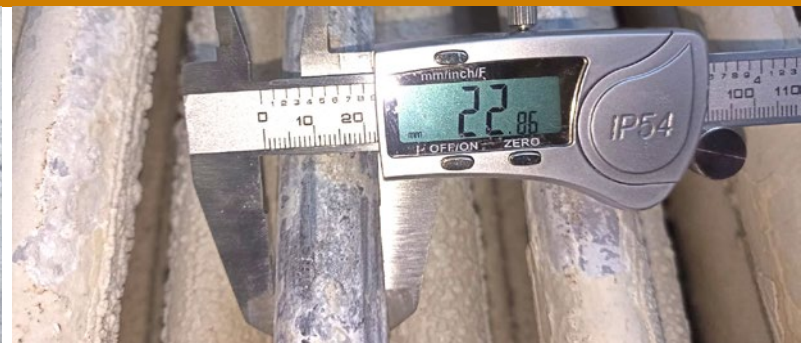
There is limescale in the cooling tubes, due to the minerals present in the water and the heat exchange.

Before using Vulcan

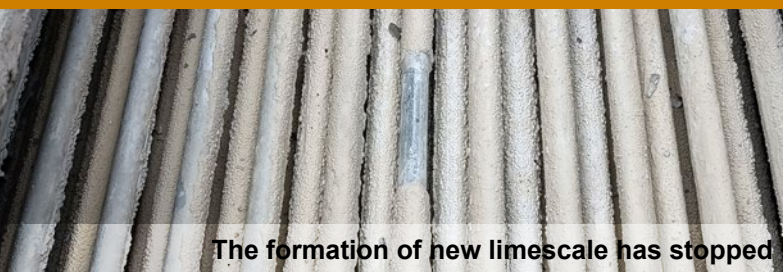
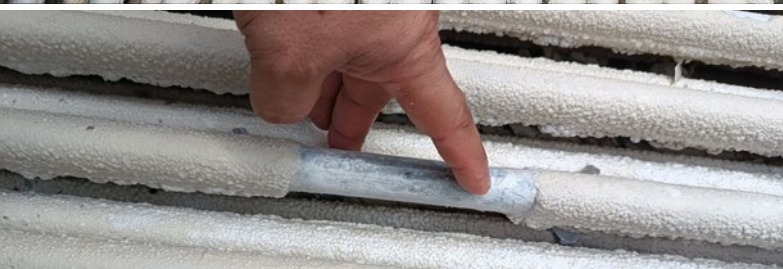
After 3 months using Vulcan

The formation of new limescale has stopped

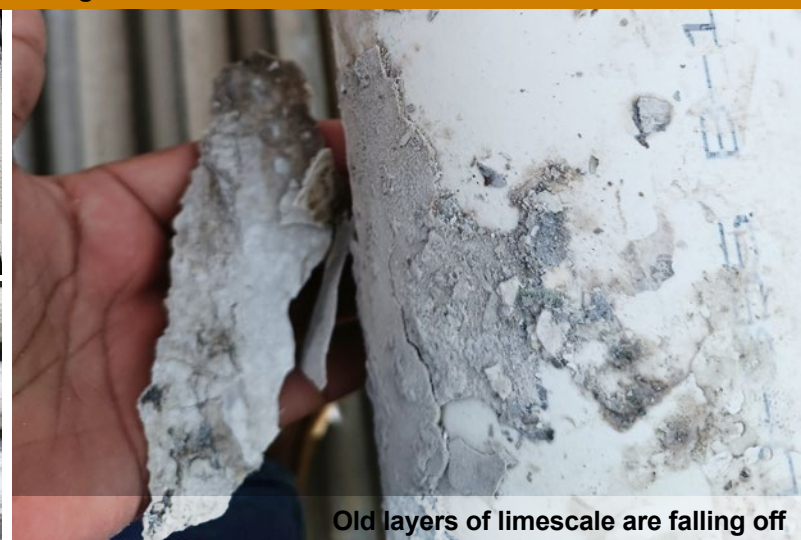
Old layers of limescale are falling off

2. The areas around the witness pipes shows that the limescale is more fragile, so it is proven that VULCAN is removing the old limescale, cleaning little by little.

3. Old layers of limescale are coming off, as can be seen in the photo.
