# VULCAN REPORT

## Condominium Crassier

### INSTALLATION DETAILS

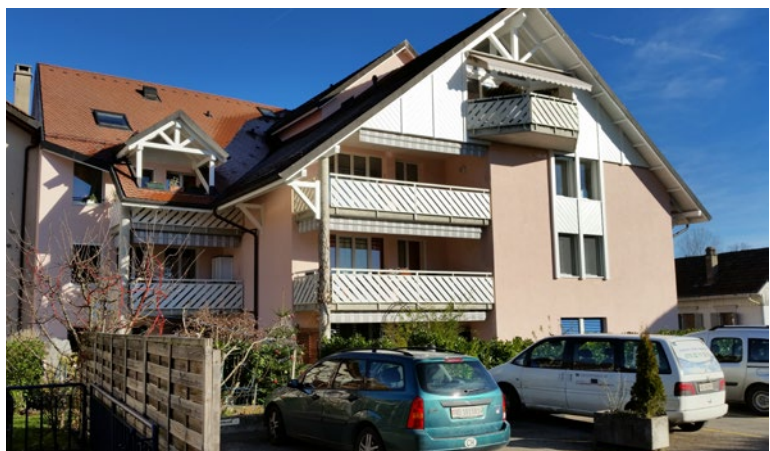
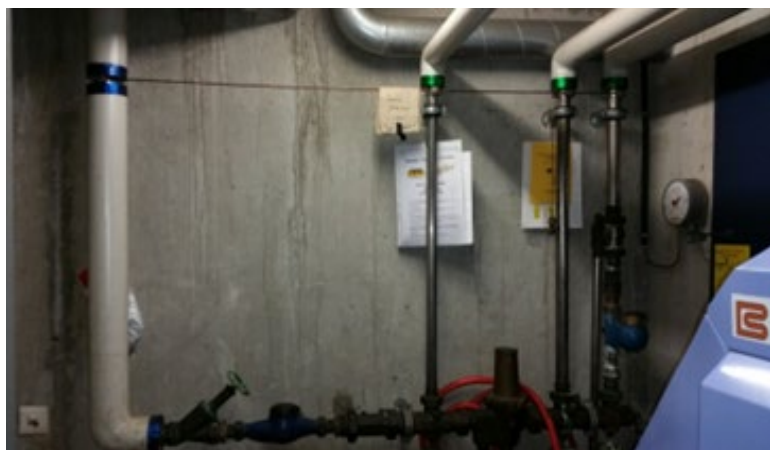
- Location:** Grindelwald Mountains, Switzerland
- Model:** Vulcan S100
- Area:** The Vulcan anti-scale system is installed in the sanitary facilities.
- Results:** After commissioning, another pH measurement was carried out at the same location using the Vulcan system. The change in lime crystallization consumes less CO<sub>2</sub> and lowers the pH value slightly, but measurably. The reduction of 0.15–0.12 is a result of the good functioning.
- Installer:**

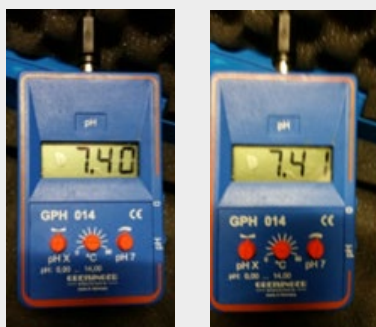
PH before installation:

### pH measurements
