Chuishan Hot Spring Resort

Installation Details

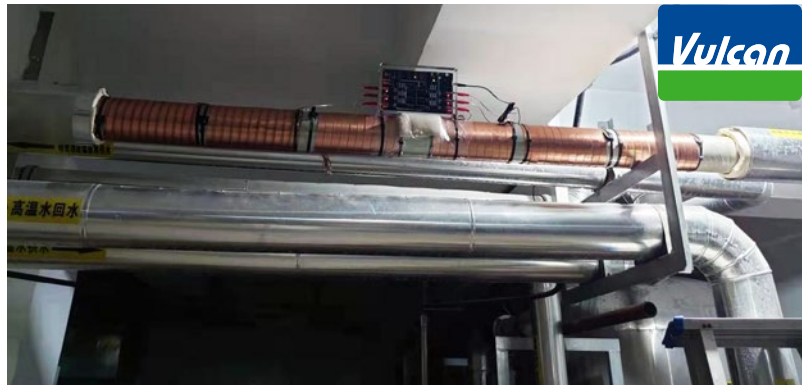
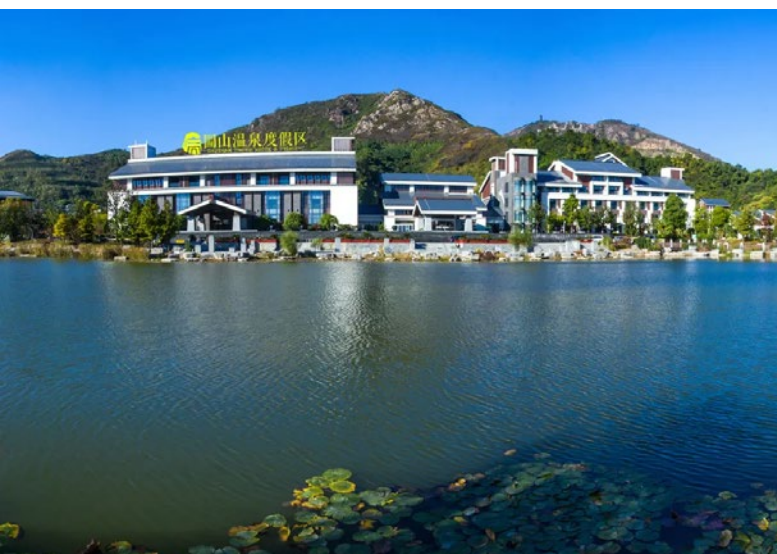
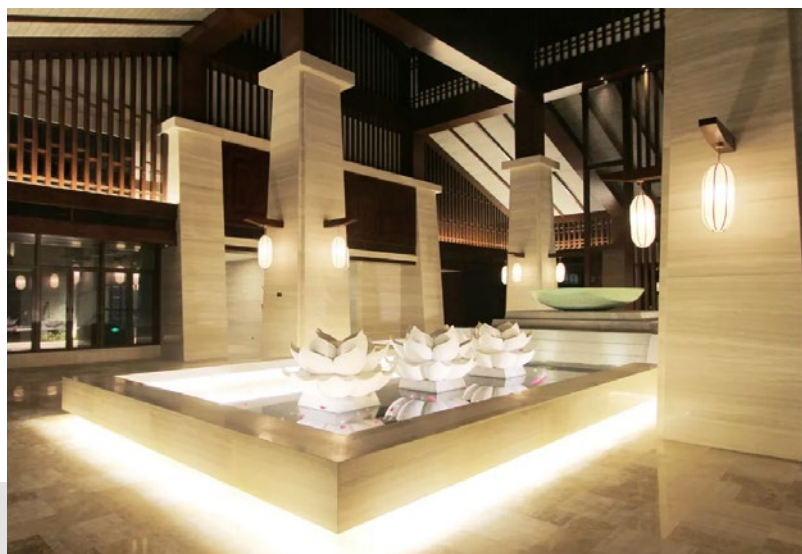
6 months after installing Vulcan S100

Problem: The scale blocked the pipeline and could not be cleaned with chemicals. It must be cleaned manually. The pipe valve parts needed to be replaced regularly.

After 6 months of installation, the pipe still has not been cleaned. Through the annual water shutdown inspection to view the effect, the scale in the hot spring water pipe has been significantly reduced.
