Installation details

Location: Furama Hotel Dalian
www.furamahoteldalian.com

Model/Area: **Vulcan S25** installed on the inlet pipe of the hot water volumetric heat exchanger on the 31st floor of the West Building to solve the scale problem on the 12th to 25th floors.

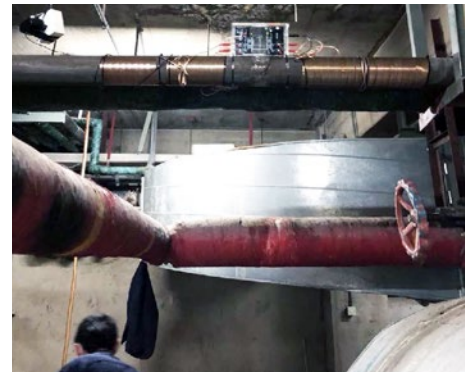
Vulcan S25 installed on DN80 copper pipe.

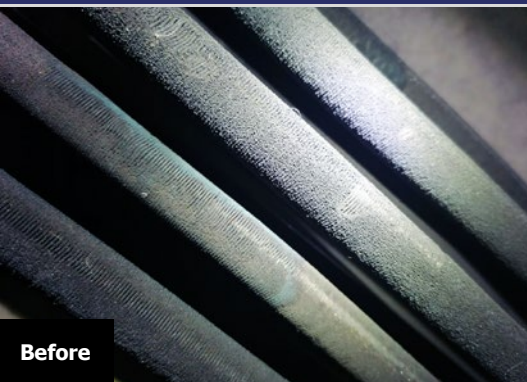
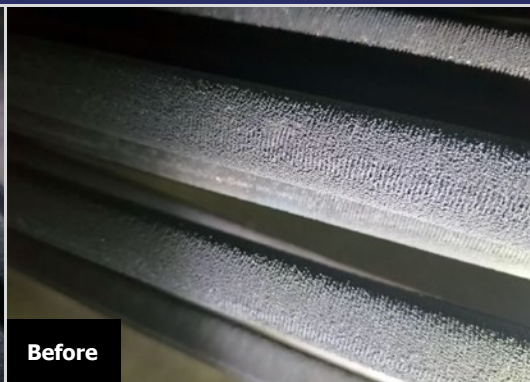
Before

Heating elements in the heat exchanger

The hard scale between the fins affected the heat transfer efficiency and rusting caused problems with rusty water.

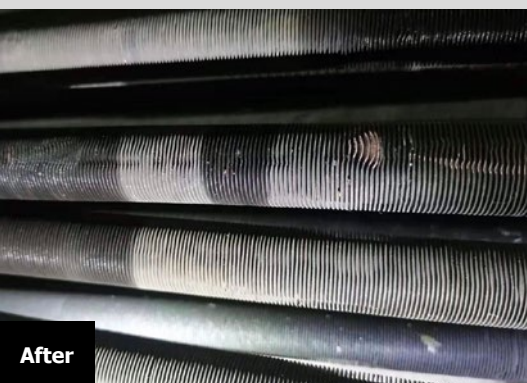
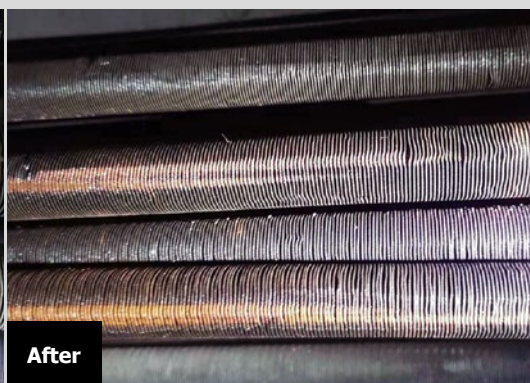
After

The fins were not cleaned before installing the Vulcan S25. 10 months later, the hard scale between the fins was removed and some areas were clean and even revealed the original colour of the copper tube. Vulcan has improved the water quality and saved energy and manual cleaning costs.

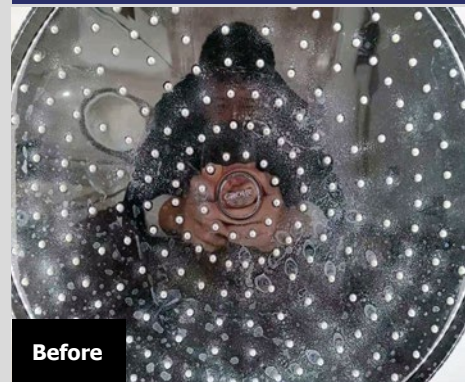
Before

After using shower heads, a layer of scale would build up on the surface, giving it a dirty look.

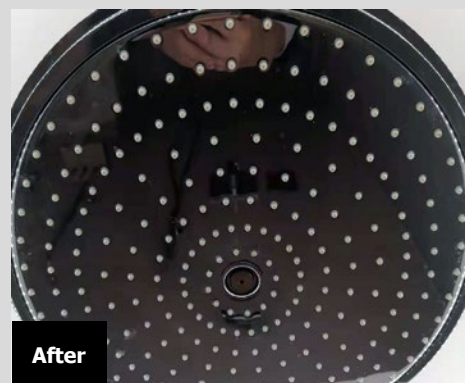
After

No more scale build-up on the surface of the shower heads, and the water outlet is no longer blocked, which saves the cost of replacing and cleaning nozzle.
