Installation details

Jizhong District Heating Company

The heat exchange station — Vulcan effect on the plate heat exchanger

The domestic hot water system — Vulcan effect on the plate heat exchanger

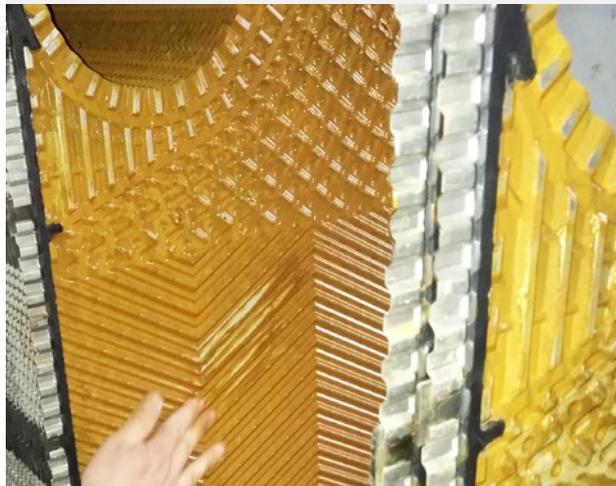
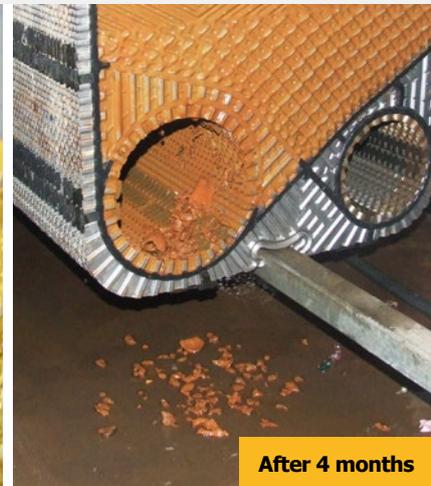
After 4 months

Vulcan S500 was installed in the heat exchange station.

The water is underground well water. Vulcan S500 was installed after cleaning the plate heat exchanger. After 4 months, no white scale was seen, only yellow rust was left. Although there were still substances in the plate heat exchanger, they had been softened.

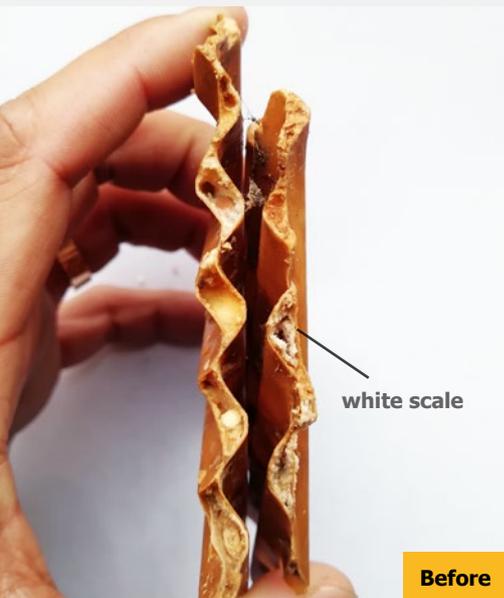
Before

white scale

Without Vulcan S250, the plate heat exchanger was scaled badly, and it was almost blocked every month, must be cleaned manually. The scale was hard, could not be removed by hands.

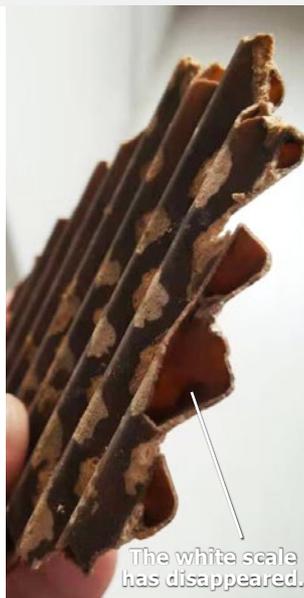
The white scale has disappeared.

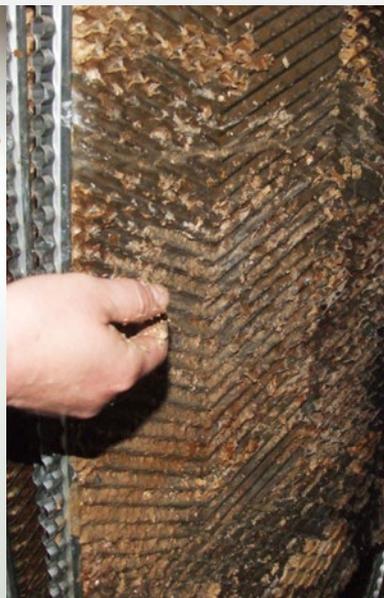
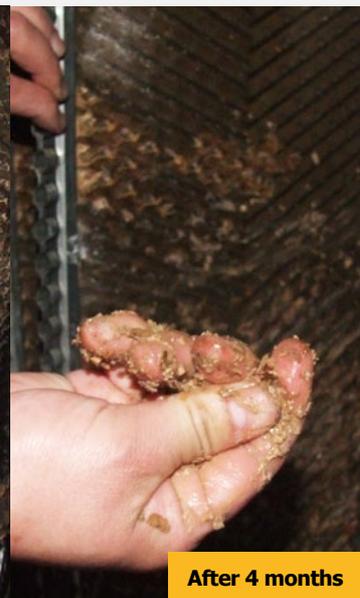
After 4 months

We stopped using any additional chemicals to treat the water. After installing Vulcan S250 for 4 months, the effect was very clear. Although there were still substances in the plate heat exchanger, they had been softened and could be easily removed by hands. There are no more white scales, only yellow-brown impurities left.
