Installation Details

Location: Starcastle Xiangshan Nursing Home
Beijing, China

Model: Vulcan S25

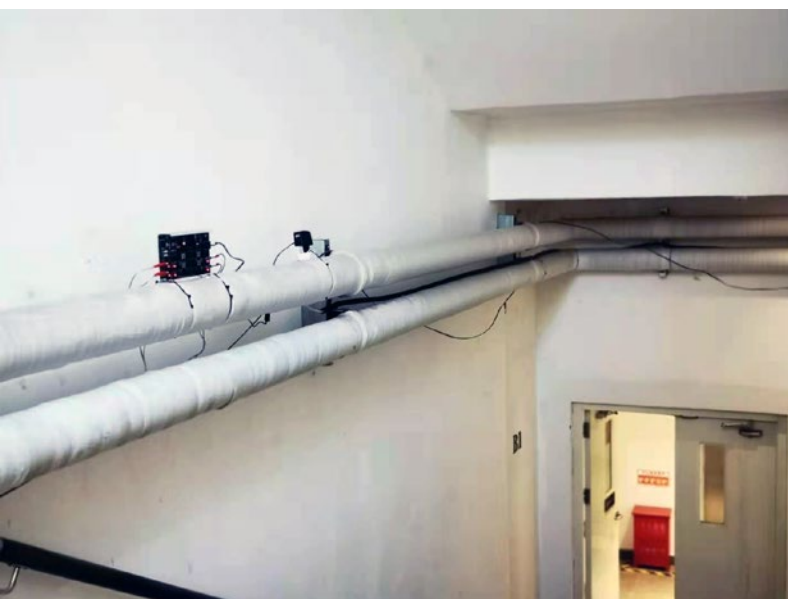
Vulcan S25 was installed on the main pipe leading to the heat pump in the stairwell.

Area: On the main pipe of the heat pump

Result: After **9 months** of installation, Vulcan effectively solved the scaling problem, the heat pump always runs efficiently and does not require frequent cleaning with acid. The circulating water pump has not been blocked and burned due to scaling, and the pipeline scaling has gradually fallen off and been significantly reduced, greatly reducing maintenance costs and avoiding the use of chemicals for scale inhibition.
