The Electronic Anti-Scale System For Industrial Applications

The Vulcan-Impulse-Technology

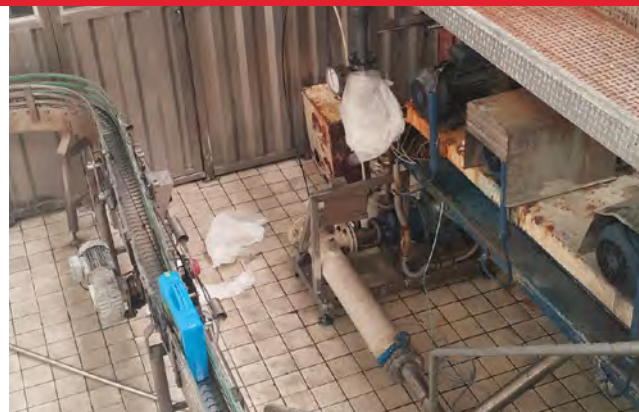
Before Vulcan installation: the pipe was full of scale deposits.

1. Two weeks after Vulcan was installed, lots of scale deposits had disappeared in the pipe.
2. 48 hours after Vulcan was installed, the filter still stays clean.
3. Less maintenance.

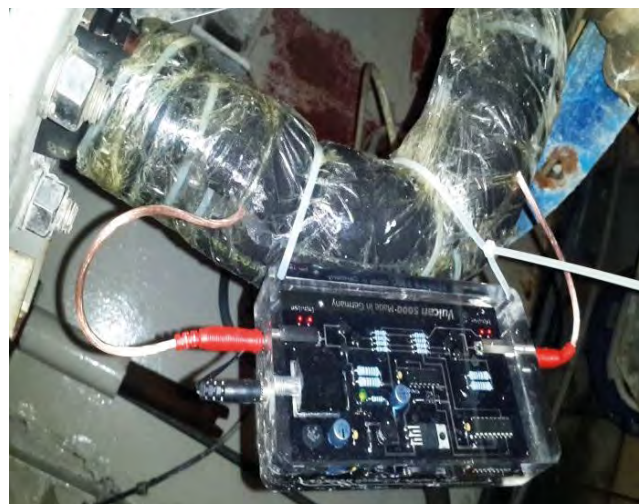
Vulcan 5000 was installed on the water inlet of the water recycling room.

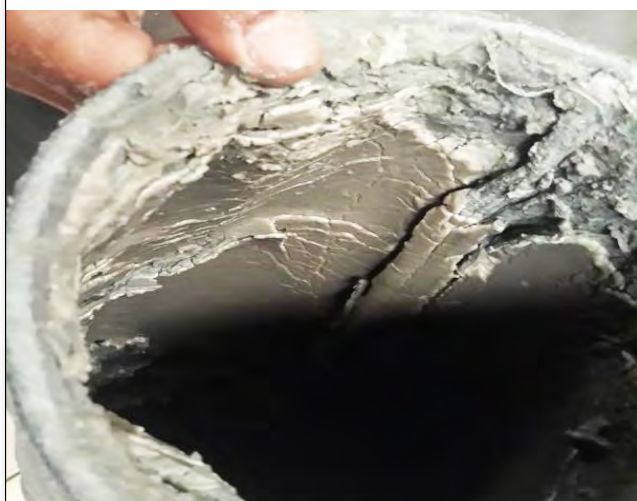
Without Vulcan, the filter was quickly stuck by scale deposits, and it had to be changed every 48 hours.

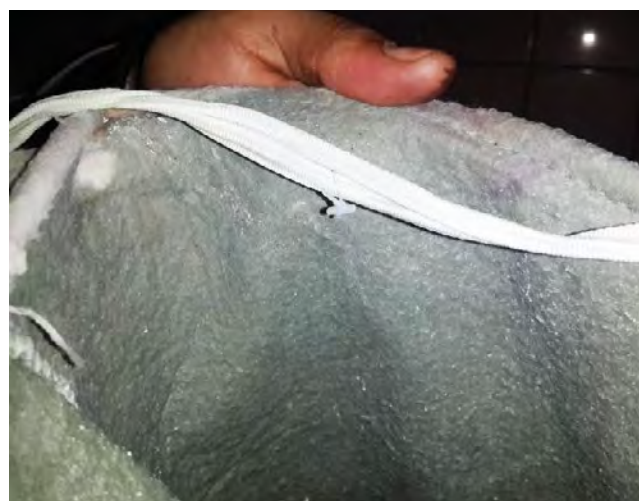
48 hours after Vulcan was installed, the filter still stays clean.

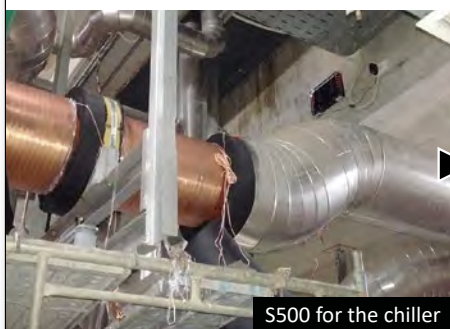
S500 for the chiller

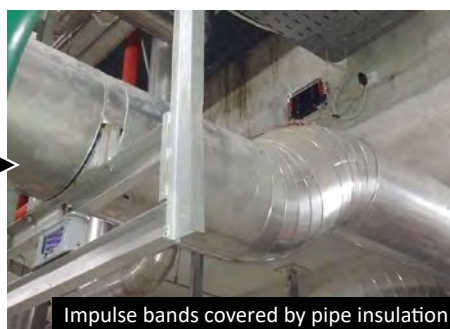
Impulse bands covered by pipe insulation

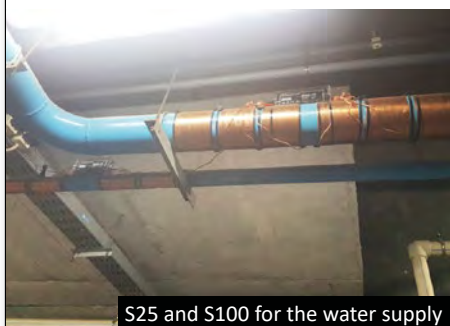
S25 and S100 for the water supply

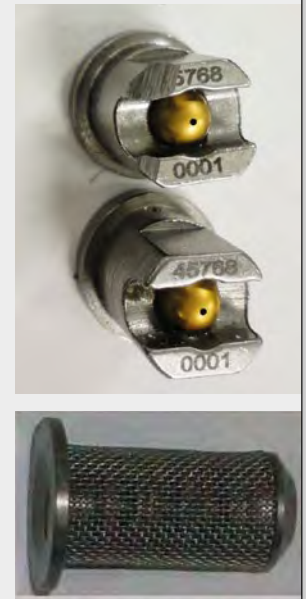
After 3 weeks with
Vulcan S25 installed

Vulcan results: S25 has been installed for 3 weeks.

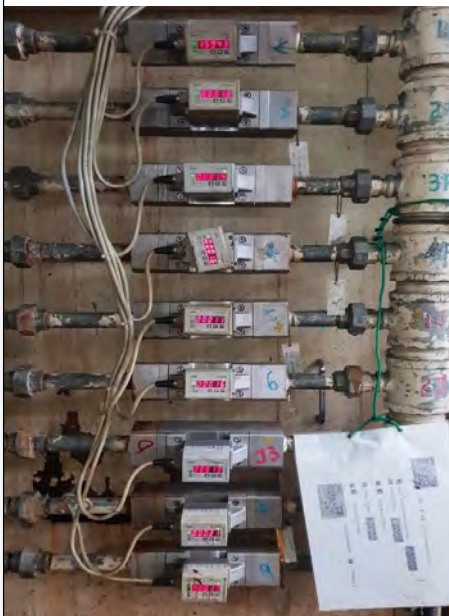
There are 9 secondary small pipes with water meters. These meters were installed to make sure a stable flow rate. If the flow rate goes down, it would cause a problem of the induction hardening machine. Therefore, the pipes had to be cleaned manually every 2-3 months.

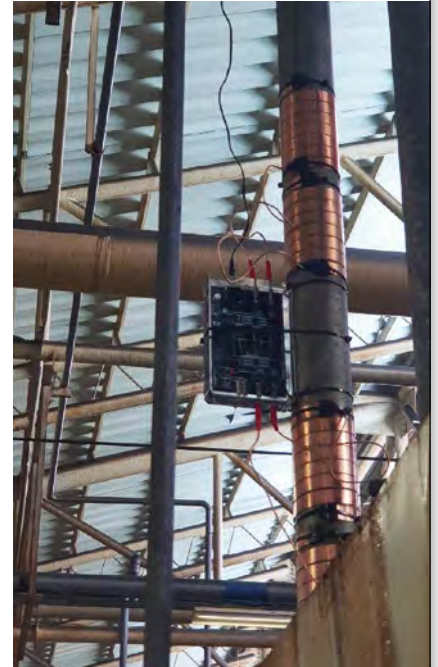
Vulcan S25 was installed around 50 meter before the induction hardening machine.

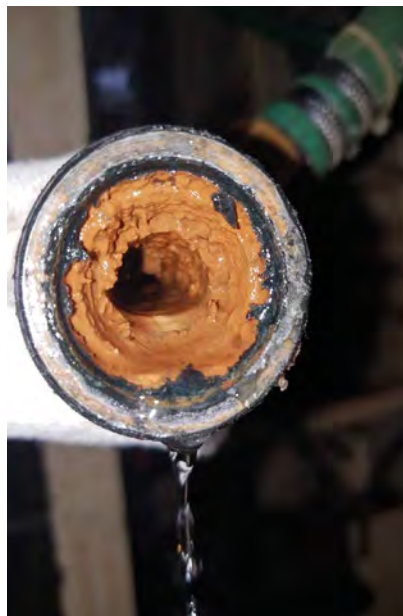
First inspection:
May 21, 2018.

Inside of a secondary small pipe, before Vulcan S25 was installed.

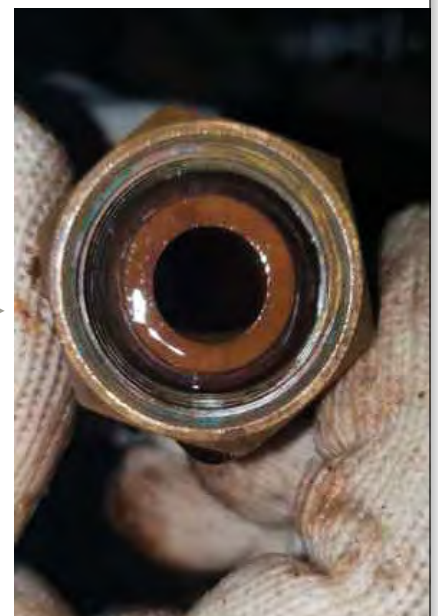
Last inspection:
November 21, 2018.

After 6 months with Vulcan treatment: the pipe is free of scale.

2. After Vulcan S25 had been installed for 6 months, the secondary pipes were opened: scale that had been left in piping had disappeared and all 9 secondary pipes had become clean (see photo).

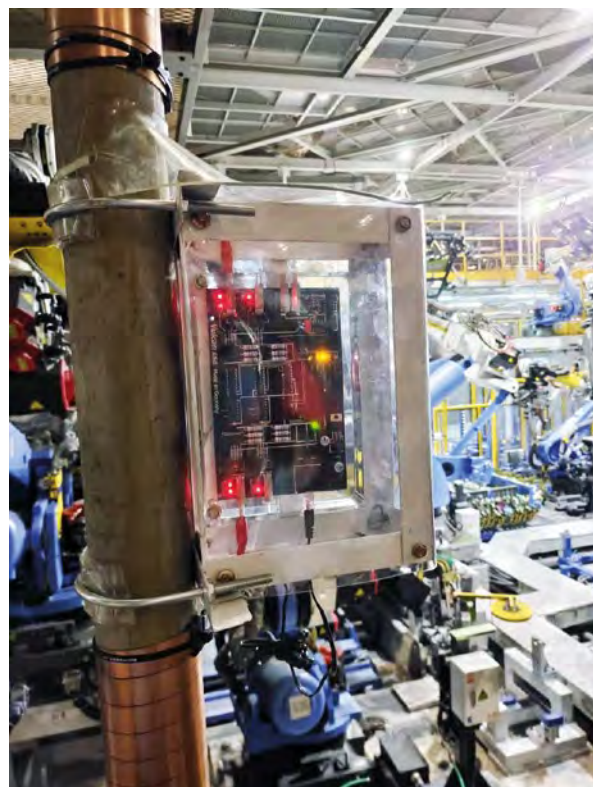
Vulcan S25 is installed on the main pipeline of the circulating water system for the production robots.

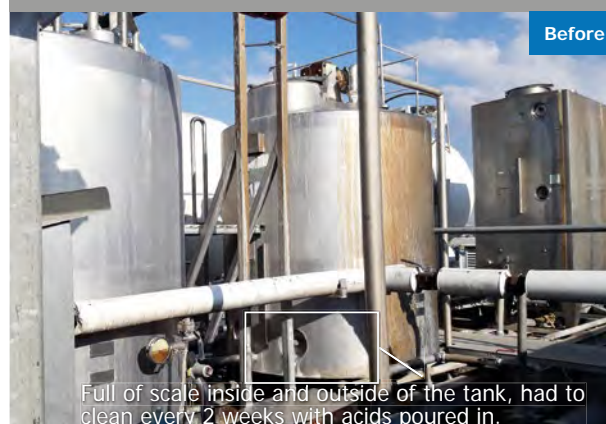
Before

Full of scale inside and outside of the tank, had to clean every 2 weeks with acids poured in.

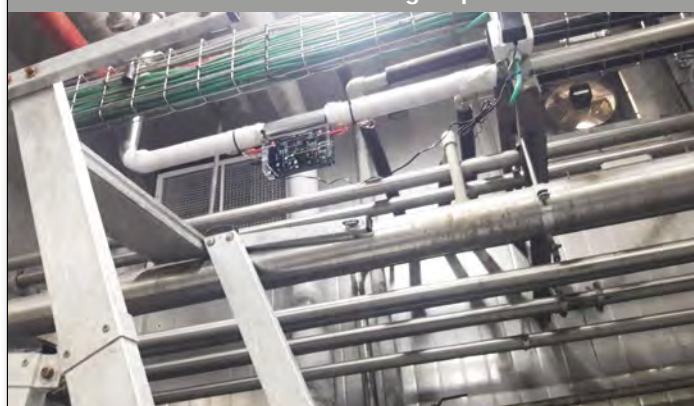
Without Vulcan, the hot water pipe was blocked and the production had to be stopped to replace it. The Vulcan S10 was installed on the supply pipe and solved the problem.

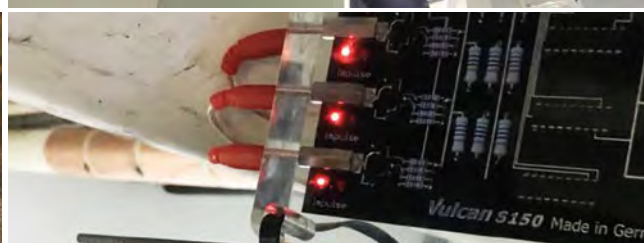
The S150 was installed on the pipe of the dust-free workshop to treat the water for the injection molding machine.

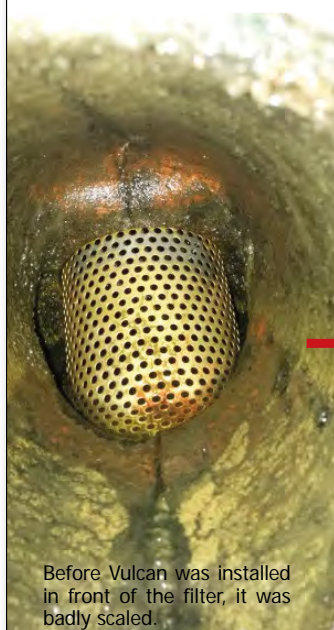
Before Vulcan was installed in front of the filter, it was badly scaled.

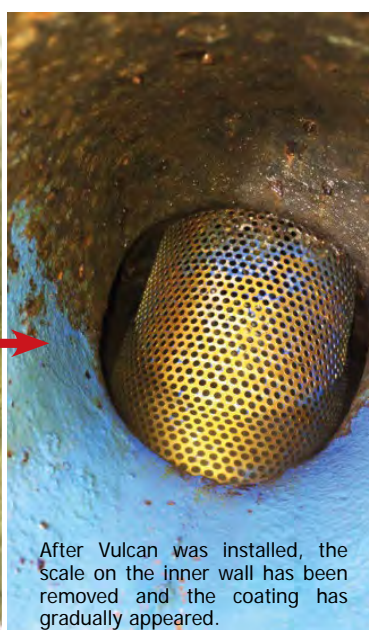
After Vulcan was installed, the scale on the inner wall has been removed and the coating has gradually appeared.

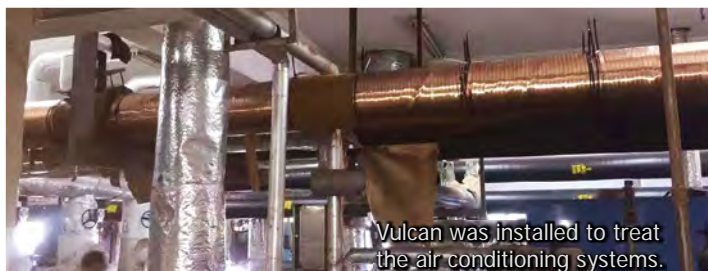
Vulcan was installed to treat the air conditioning systems.

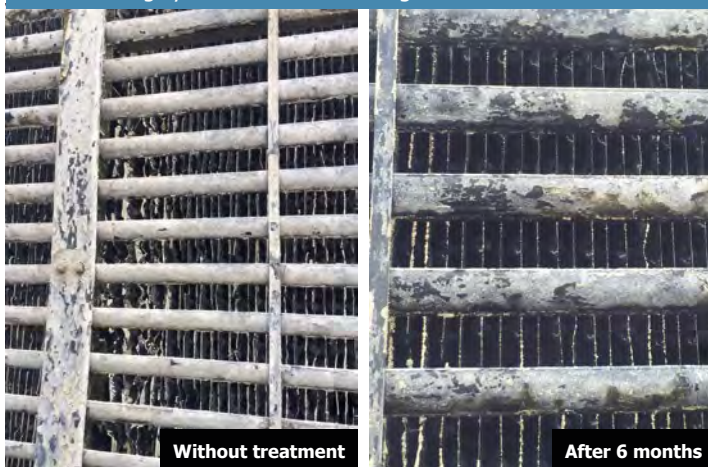
Cooling tower fins: the silica (SiO_2) which was usually accumulated in the fins has disappeared; the energy consumption of the air conditioning systems and the cleaning effort have been reduced.

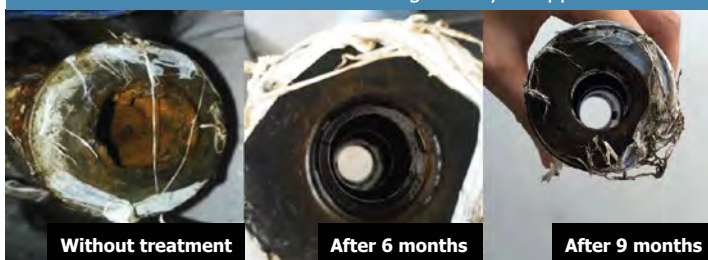
Pipe fittings in the office: they were seriously corroded, now the rust and mud on the inner wall have gradually disappeared.

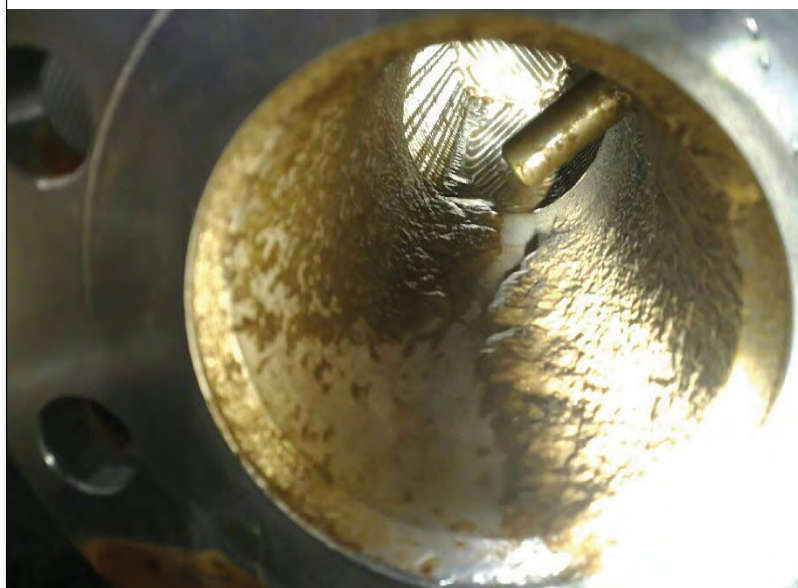
Vulcan S25 installed at Toray Industries

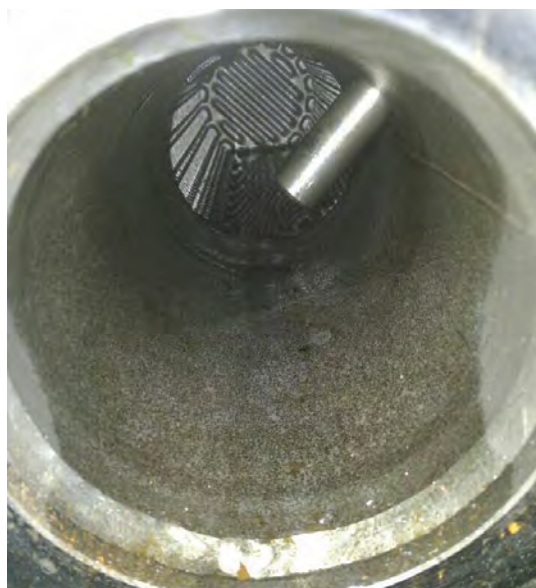
Before – without Vulcan

1. Scale problem on the plate heat exchanger
2. Regular (every 2-3 months) chemical cleaning of the pipes and heat exchangers

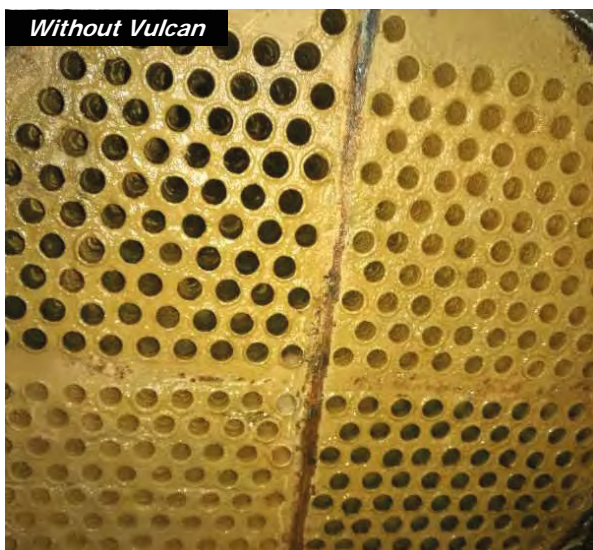
Without Vulcan

Before installing Vulcan, the scale was very thick and hard in the heat exchanger tubes.

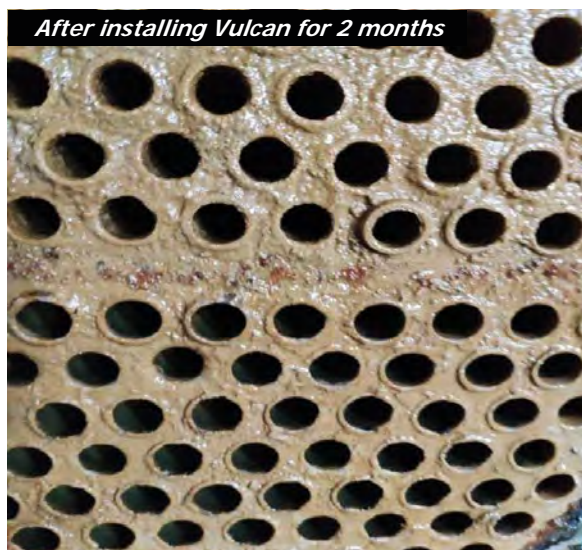
After installing Vulcan for 2 months

The scale becomes soft and muddy.

S25
 Result: After 2 months, the heat exchanger was opened. It was found that the scale on the wall of the heat exchanger became muddy and easy to clean.

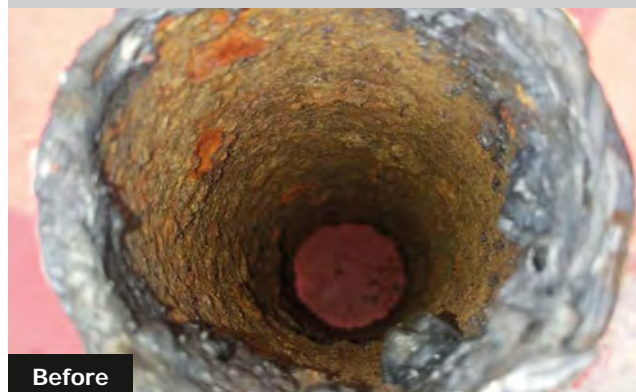
Before Vulcan was installed, the pipe was scaled and rusty.

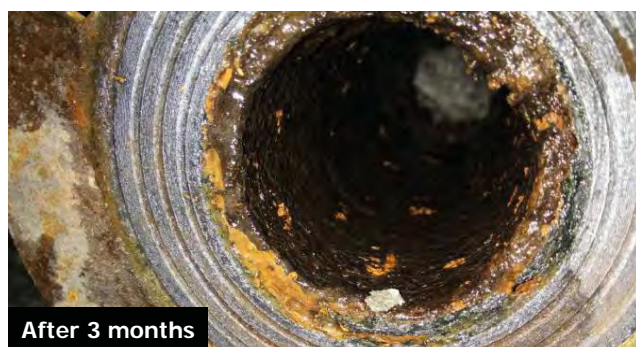
After 3 months

The outer rust had been fallen off completely.

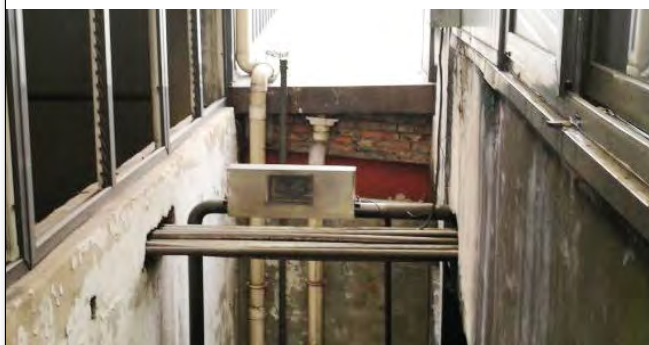
Vulcan S25 outdoor installation

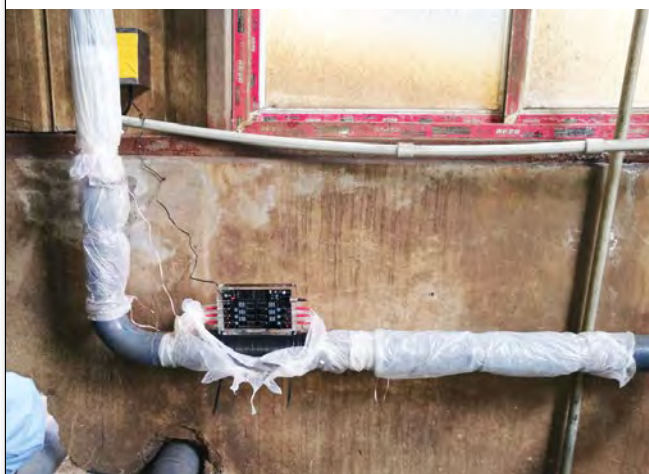
Vulcan S100 was installed in the sewage room to treat the sludge dewatering machine.

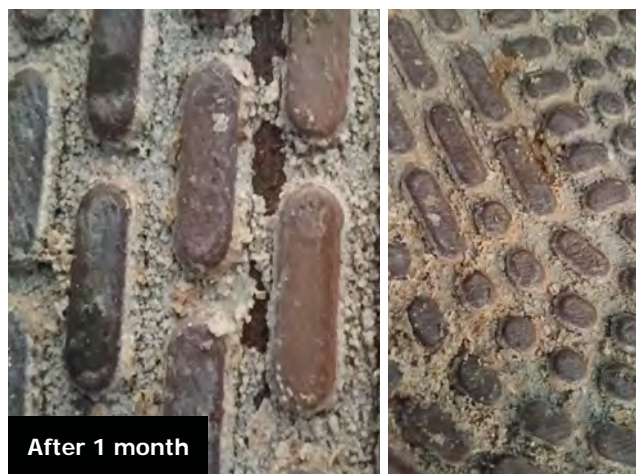
After 1 month

After Vulcan had been installed for 1 month, the scale was softened and falling off.

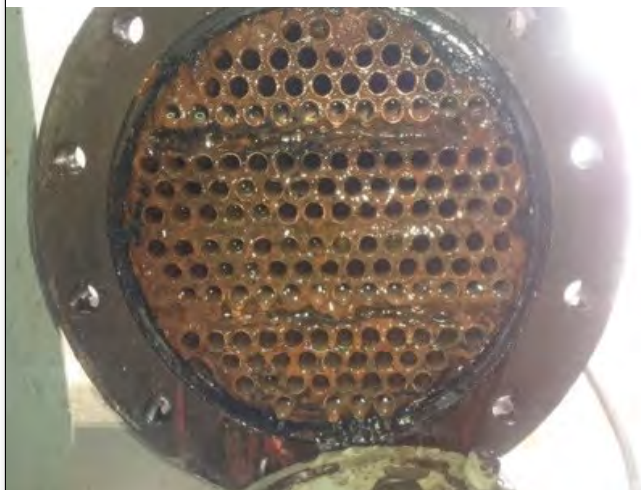
Heat exchanger before Vulcan installation

- scale deposits in oil heat exchanger
- oil temperature >50°C: very high
- to clean every month
- heat exchanger has corrosion
- scale deposits clog the pipe

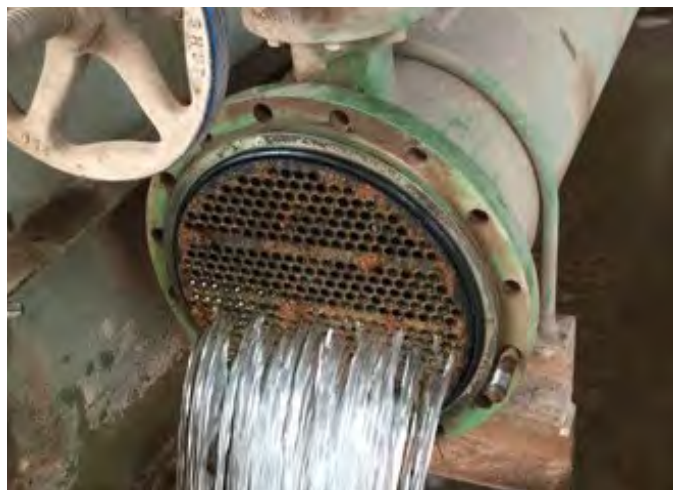
Heat exchanger after 2 months Vulcan installation

- oil heat exchanger is clean
- temperature is stable at 37°C – 40°C
- no need to stop machines to clean anymore
- save 7% energy consumption at grinders

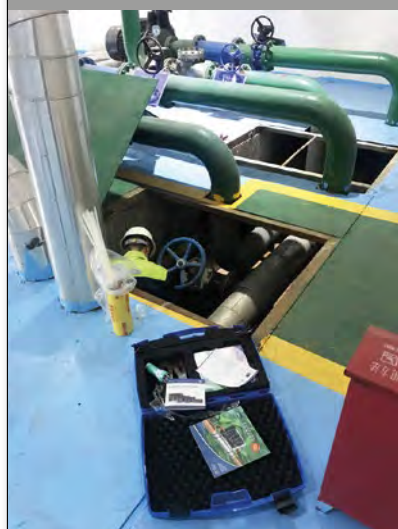
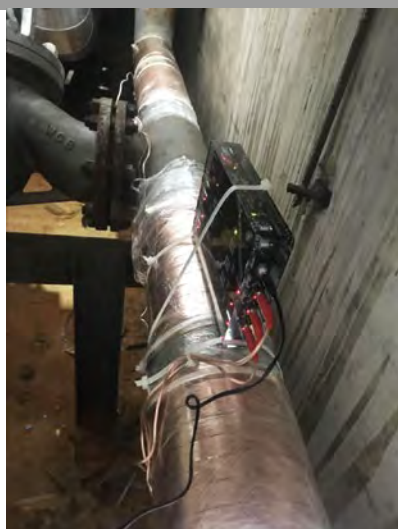
Vulcan S150 was installed at the circulating water inlet of the chiller.

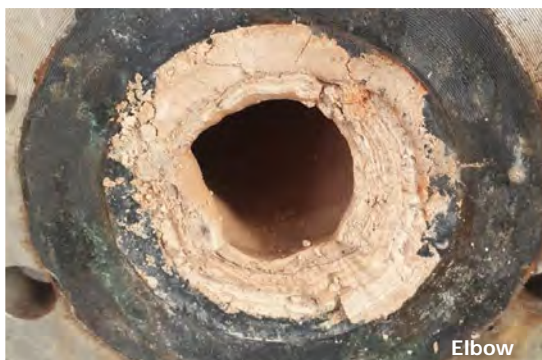
Hot water return pipe to the exchanger for cooling

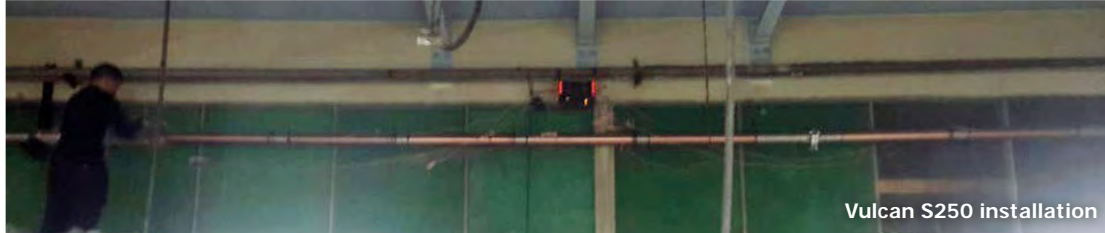
We installed the Vulcan S250 before the hot water return pipe to the exchanger for cooling.

Vulcan S250 installation
