# References and Studies

Cooling Towers / Chillers / Heat Exchangers

# Vulcan Reference Database

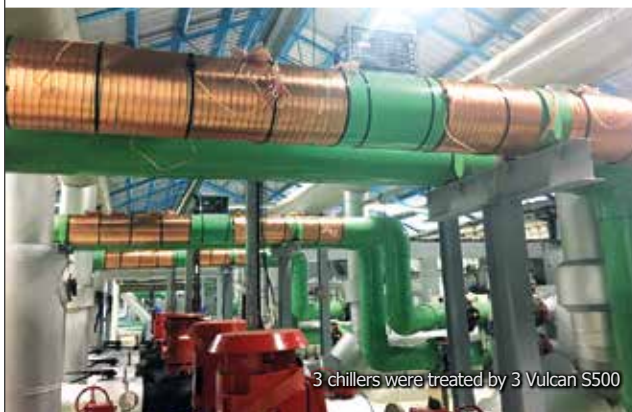
3 chillers were treated by 3 Vulcan S500

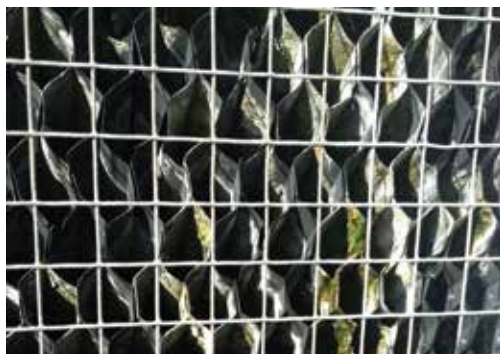
The photo above was taken of CT-1 about **3 weeks** after the Vulcan was installed.

**After 1 month**, the green biofilm had almost completely disappeared from the surfaces in contact with the Vulcan-treated water. The flakes of scale previously observed had fallen off in most places. The cooling tower flute surface area covered with scale deposits had been decreased by **over 60%**.

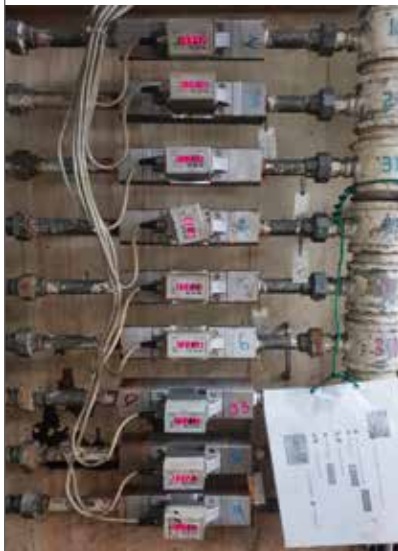
There are 9 secondary small pipes with water meters. These meters were installed to make sure a stable flow rate. If the flow rate goes down, it would cause a problem of the induction hardening machine. Therefore, the pipes had to be cleaned manually every 2-3 months.

1. Scale problems in the pipelines and the induction hardening machine.
2. There are 9 secondary small pipes, they had to be cleaned manually every 2-3 months.

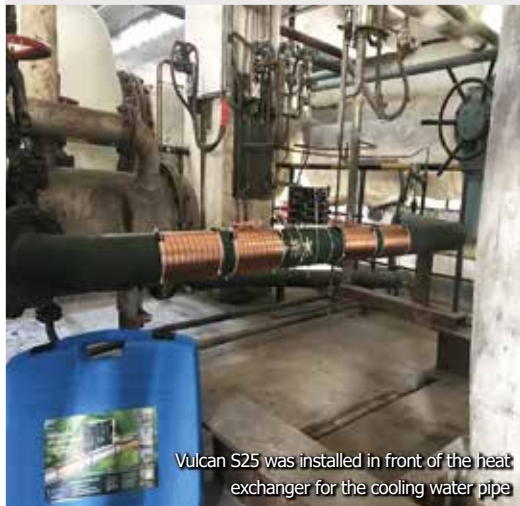
Vulcan S25 was installed in front of the heat exchanger for the cooling water pipe

S25  
Result: After 2 months, the heat exchanger was opened. It was found that the scale on the wall of the heat exchanger became muddy and easy to clean.

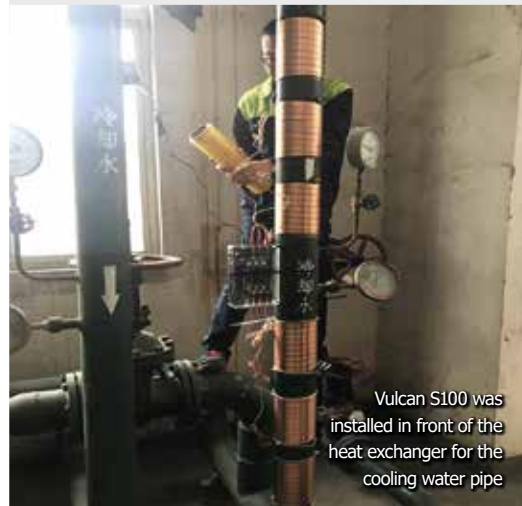
Vulcan S100 was installed in front of the heat exchanger for the cooling water pipe

S100  
Result: The water cooling system keeps running stably. It is not necessary to clean the scale every 2 months like before anymore.

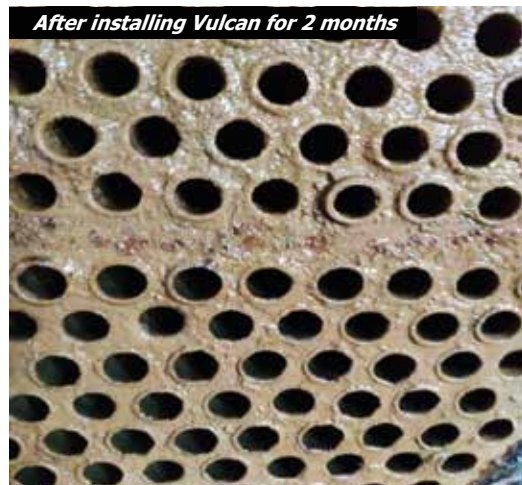
The scale becomes soft and muddy.

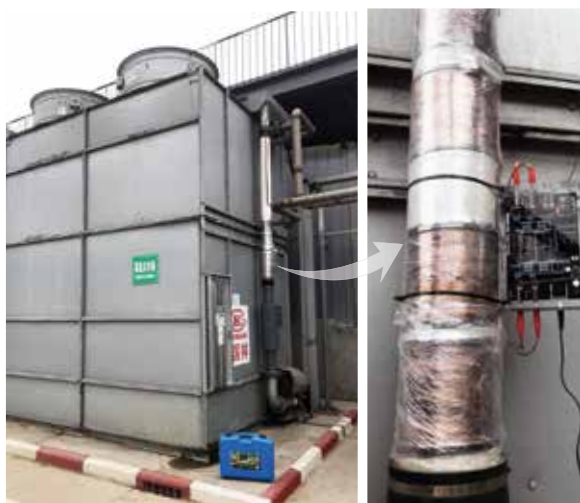
Vulcan S25 was installed at the water inlet of the cooling tower.

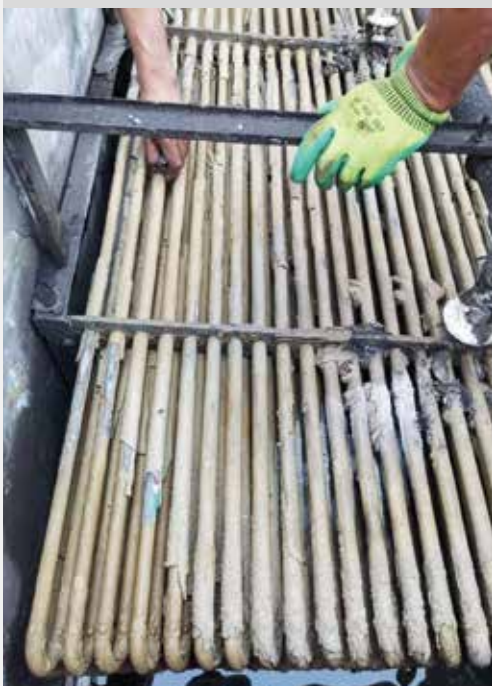
Without Vulcan, the internal cooling tower was heavily scaled, which seriously affected the heat transfer.

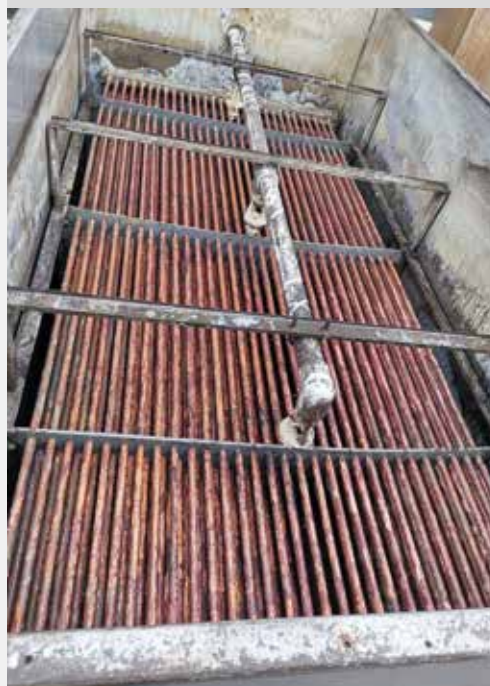
**After 6 months**, the old scale had disappeared and no new scale was formed.

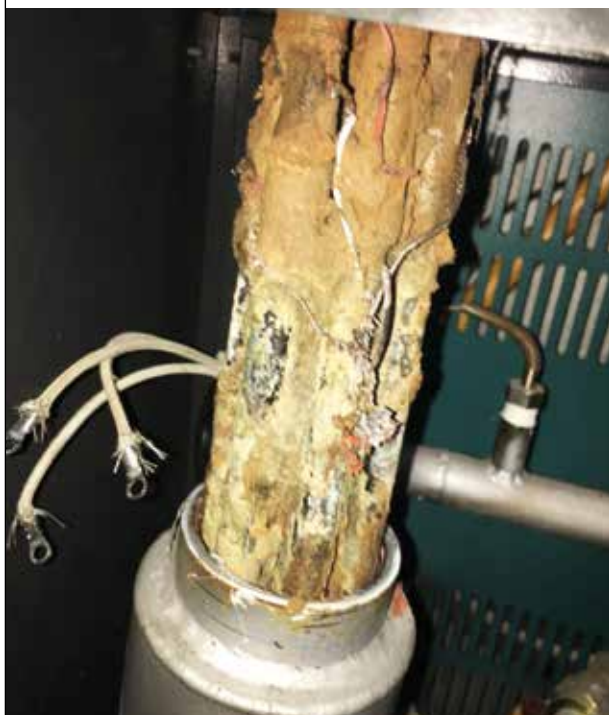
Untreated heat exchanger for 3 years.

One and a half years after Vulcan was installed, we opened the mold temperature controller and checked the heat exchanger.

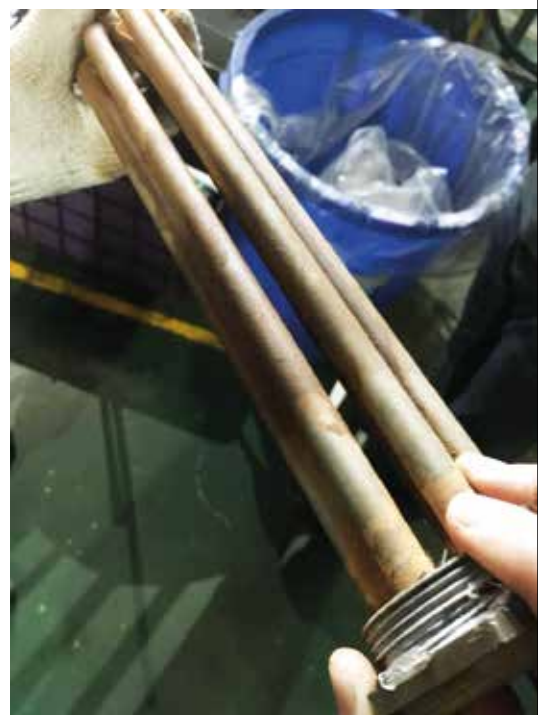
After installing Vulcan for 1.5 years, the scale is gone without extra cleaning.

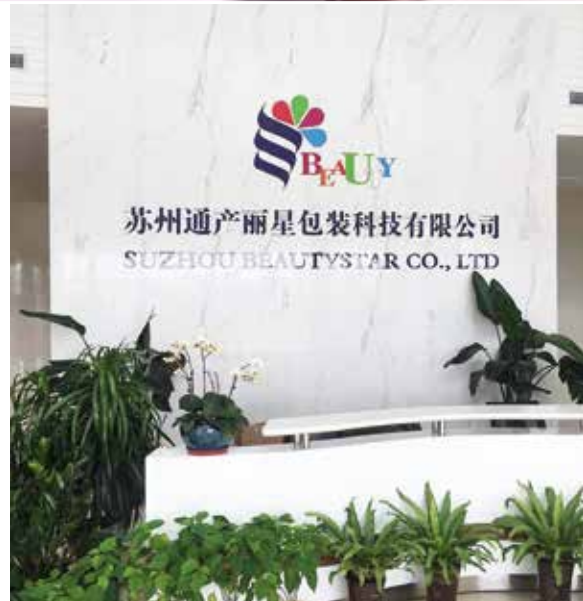
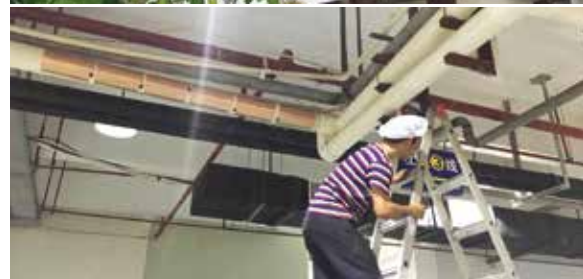
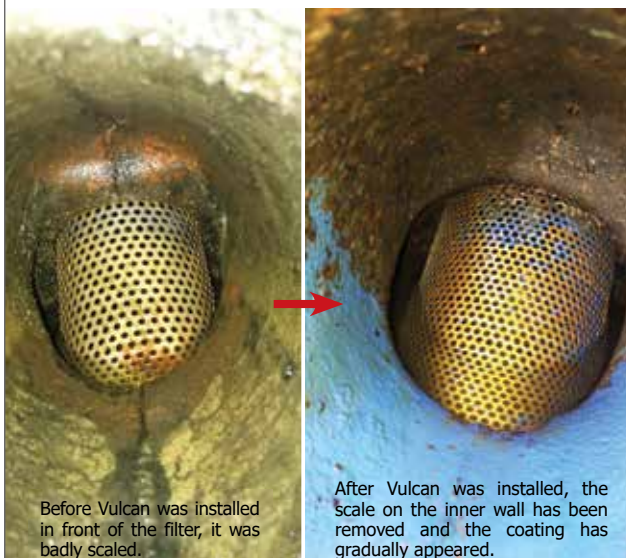
Before Vulcan was installed in front of the filter, it was badly scaled.

After Vulcan was installed, the scale on the inner wall has been removed and the coating has gradually appeared.

- When we opened the valve of the heat exchanger, we noticed that a lot of scale had disappeared
- The chiller and the cooling tower stay clean
- The "small holes" of the injection molding machine have become very clean, when they were blocked before, and the corrosion on the valve has gradually disappeared.

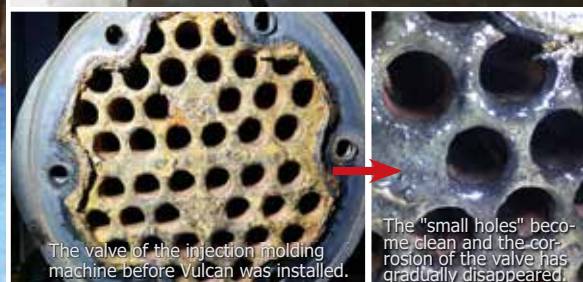
The valve of the injection molding machine before Vulcan was installed.

The "small holes" become clean and the corrosion of the valve has gradually disappeared.

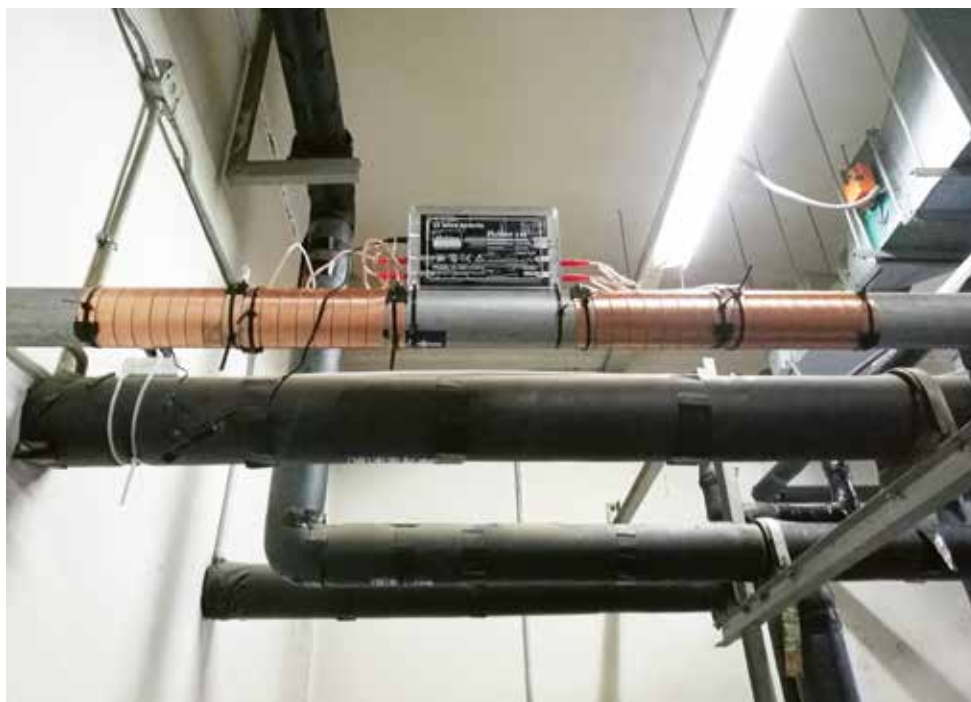
Vulcan S25 installed on the main water pipe of the cooling tower.

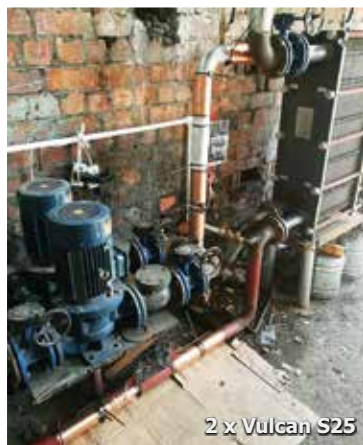
2 x Vulcan S25

2 x S25 were installed to treat heat exchangers for bathing.

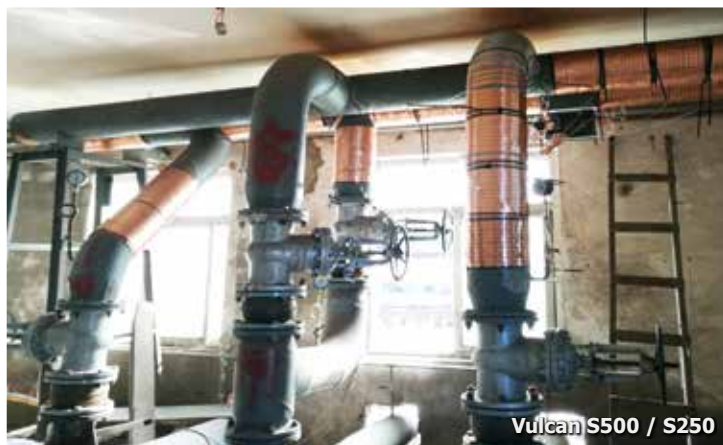
Vulcan S500 / S250

S500 and S250 were installed on the two main inlet pipes for cooling water.

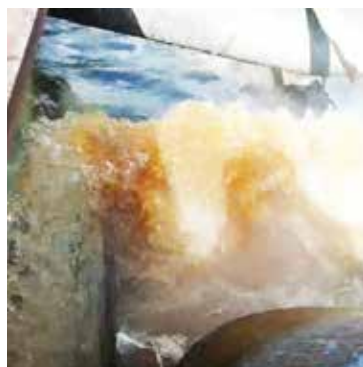
Less than 1 month after installing Vulcan, the main pipe for cooling water started to drain out rusty water.

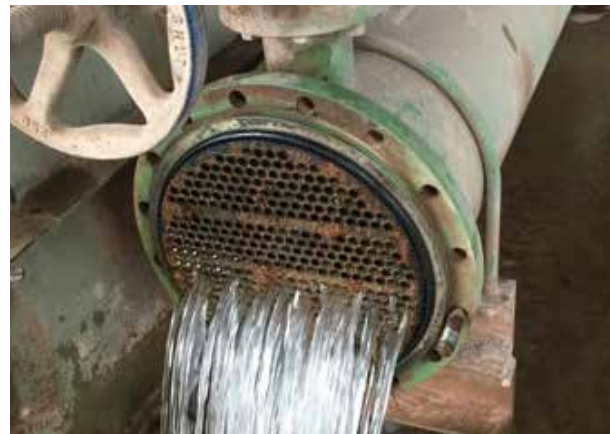
**Heat exchanger after 2 months Vulcan installation**

- scale deposits in oil heat exchanger
- oil temperature >50°C: very high
- to clean every month
- heat exchanger has corrosion
- scale deposits clog the pipe

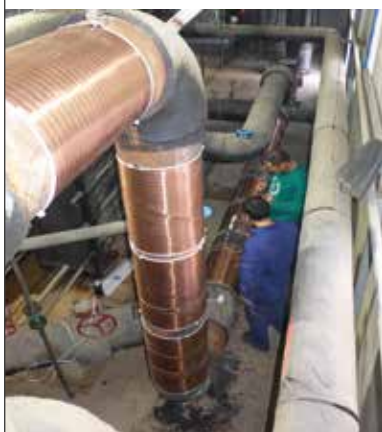
Vulcan S500 was installed in the heat exchange station.

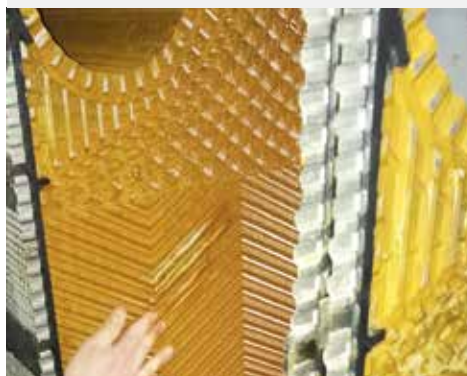
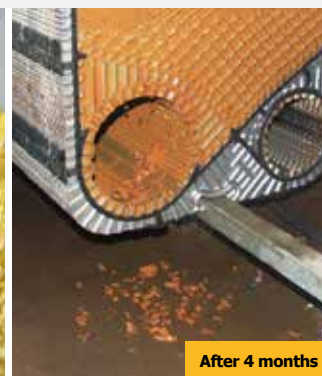
After 4 months

The water is underground well water. Vulcan S500 was installed after cleaning the plate heat exchanger. After 4 months, no white scale was seen, only yellow rust was left. Although there were still substances in the plate heat exchanger, they had been softened.

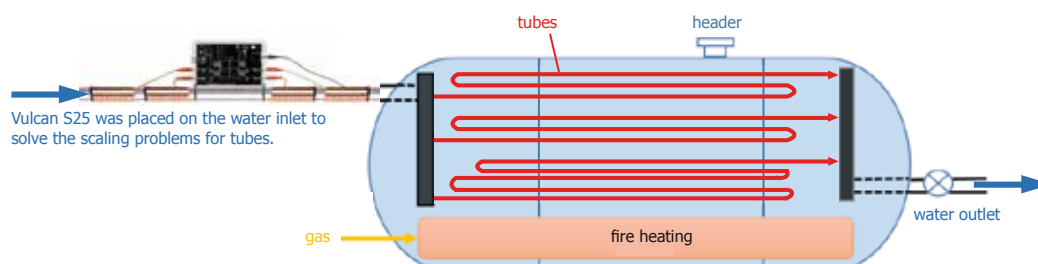
In order to heat the water in the tubes, the water temperature of the heating furnace is 70 °C~80 °C. The tubes are marked in red and have scaling problems. The tube diameter is 80mm.

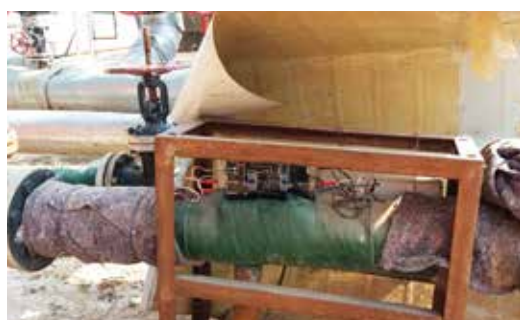
Before installing Vulcan, the rust and pipe insulation were removed, and the impulse bands were wound on the pipe. Then, the outer insulation was put back.

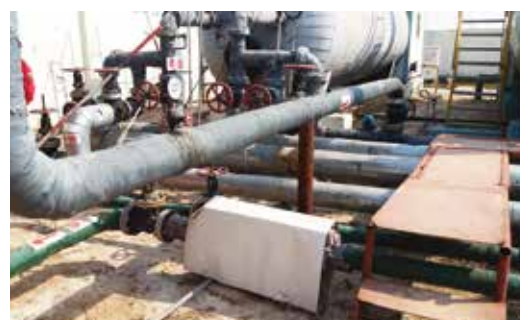
Outdoor installation with self-made cover, to protect the unit from the wind and sun.

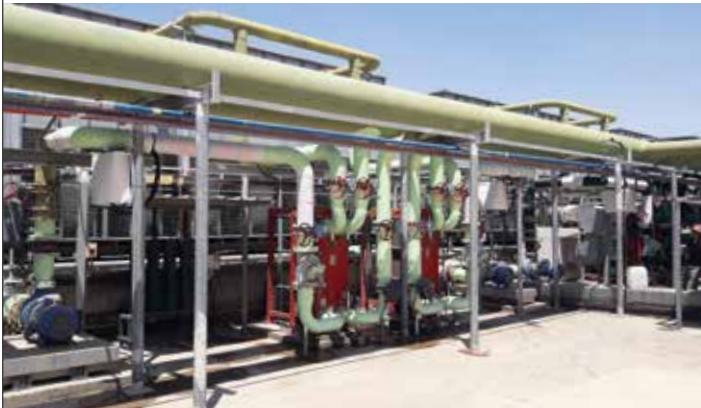
Vulcan S250 outdoor installation: on the roof, with the sun most of the year. The temperature at this time was 38 - 40 °C. In winter, it is rainy and the wrap should be sealed to IP-68. Vulcan impulse bands were well wrapped and the Vulcan unit was in the outdoor box.

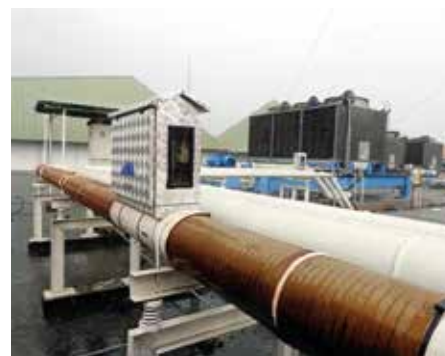
Vulcan S500 was located inside aluminum box and installed on a cooling tower main pipe in Supermal Karawaci.

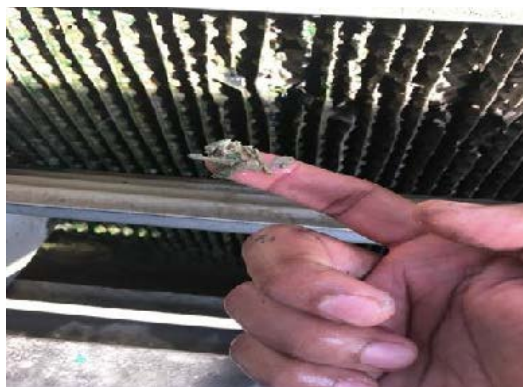
With Vulcan, scale becomes loose.

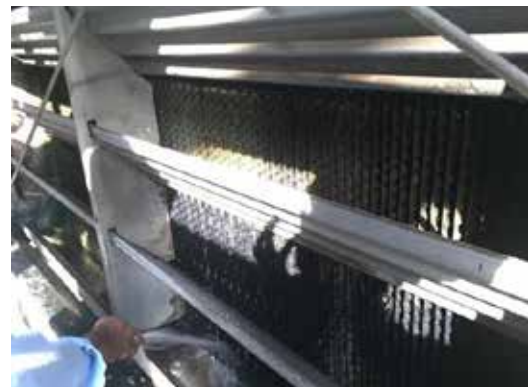
Scale and algae can be removed easily by a water gun.

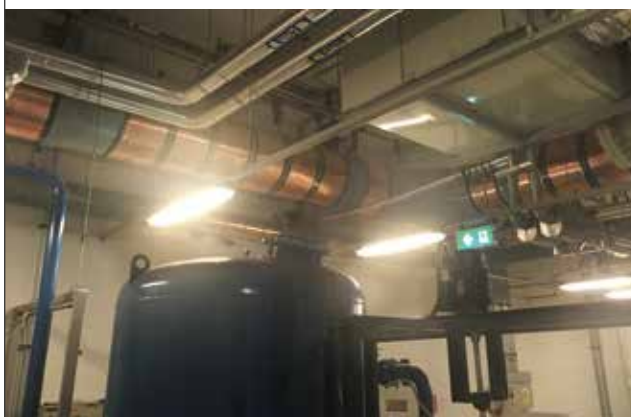
Vulcan S250 and X-Pro 1 were installed on the main return pipes of the condenser.

Before Vulcan was installed, the client used ozone water system to treat the condenser, but they still found massive scales in the basin of the cooling towers. They collected the scales from the basins and weighed them, there were around 150 kg (average) of scales every month.

Vulcan was added together with the ozone system to treat the water. After 4 months, the approach temperature of the chiller has been reduced, so that the energy has been saved from the machine. Also, the scales from the cooling tower basin have been reduced.

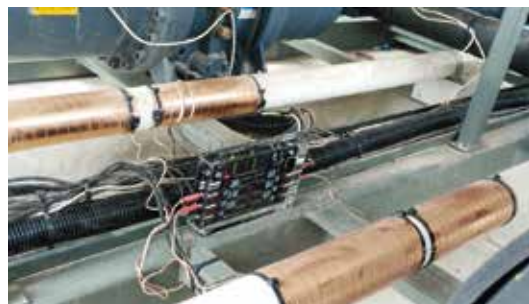
Vulcan S100 was installed on the main air-conditioning system

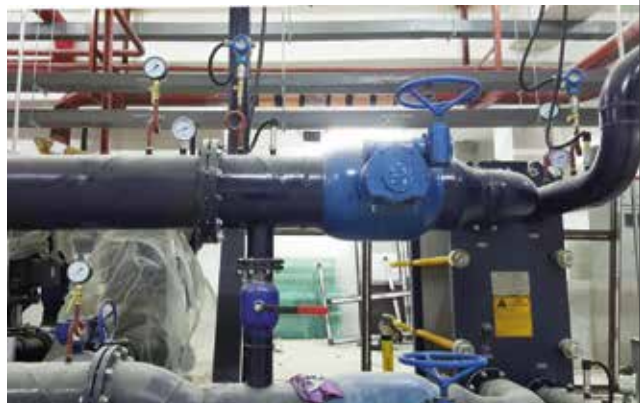
Vulcan S150 was installed in the heating system in the low zone of the heat exchange station.

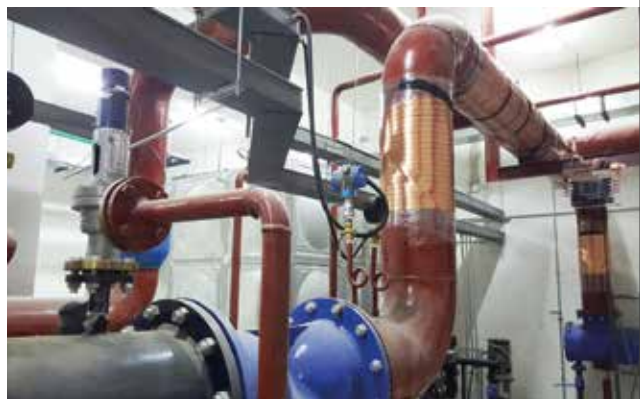
Vulcan S350 was installed in the heating system in the high zone of the heat exchange station.

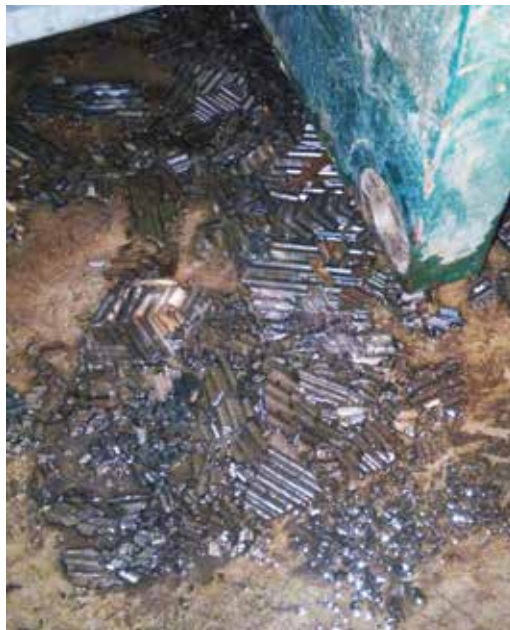
Without Vulcan treatment, the scale was removed after the end of the heating period.

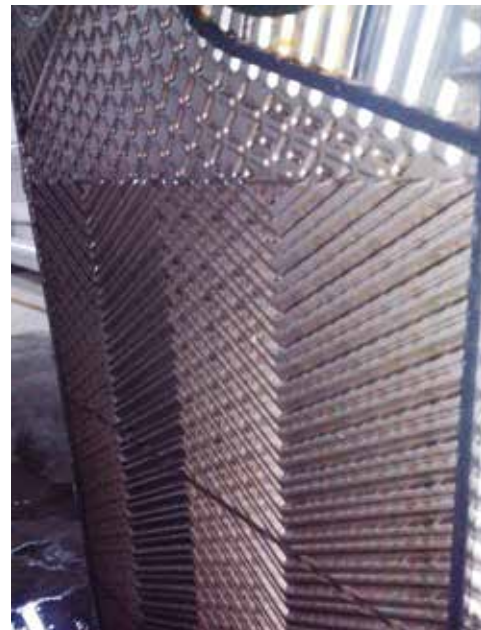
After installing S250 for 4 months, the heat exchanger plates were opened and remained clean.

The heat exchanger plates were cleaned before Vulcan S250 was installed. During the period with Vulcan, the water softener had not used also without any other water treatment. After the end of the heating period, the heat exchanger plates were opened and still clean.

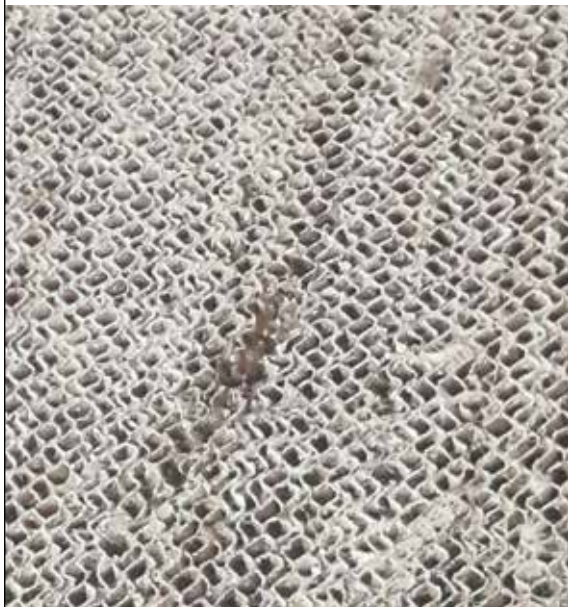
Without any water treatment, the scale was hard like stones, which had not been cleaned for more than 5 years.

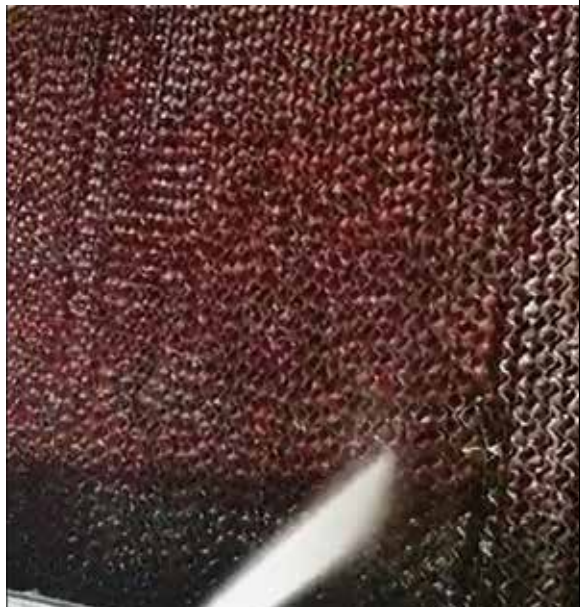
After Vulcan S10 had been installed for 2 weeks, the old scale had been softer, and the new scale had formed as powder. The new scale was easy to clean, and the old scale took more time to clean up with a water gun.
